# **PROJECT VULCAN RESEARCH and DEVELOPMENT**

**PROGRESS REPORT NUMBER 39**

**CONTRACT DA - 19 - 020 - ORD - 5455**

**1 FEBRUARY 1963 TO 31 MARCH 1963**

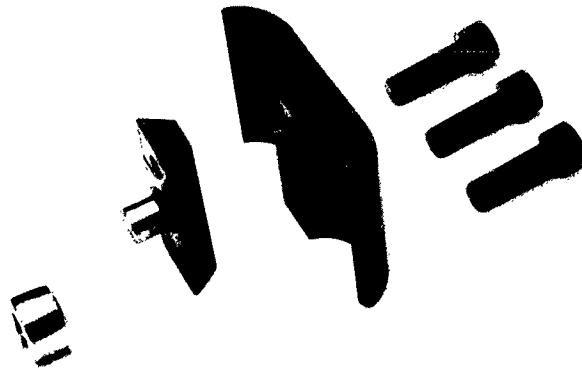
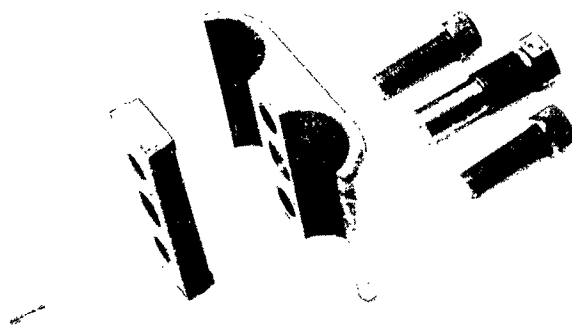
Figure 2-2. Inner Clamp and Roller Support

- (1) The inner clamp and roller support were changed to make it possible to remove the cam follower without removing the gun barrels (Figure 2-2).
- (2) The cam follower is now made of tungsten carbide. This change has resulted in an increase in the life of the follower from less than 1,000 rounds to more than 20,000 rounds.
- (3) The drive cam is now a high nickel alloy steel. This has resulted in an increase in the life of this part from about 5,000 rounds to over 20,000 rounds.

OLD STYLE

NEW STYLE

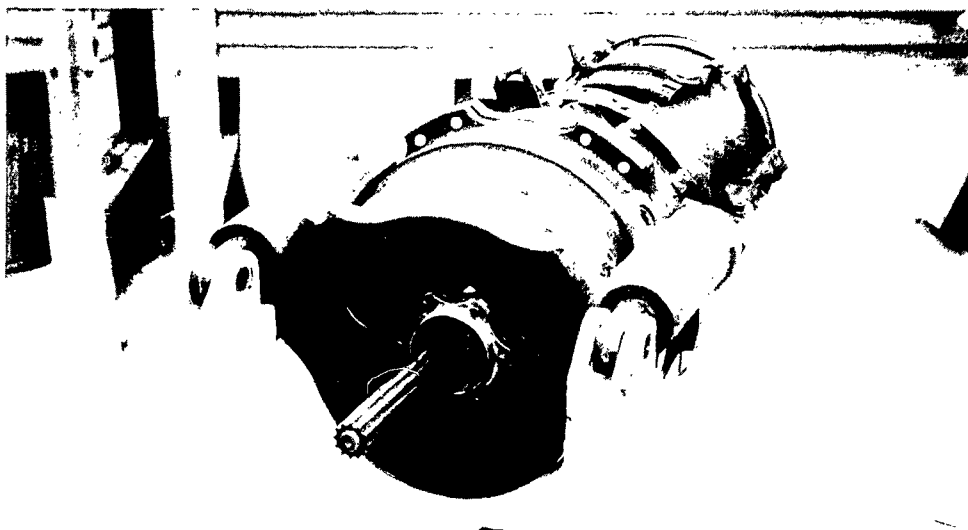
1. Assemble modified stub rotor to standard gun (modification consists of the addition of a bronze bearing as shown).

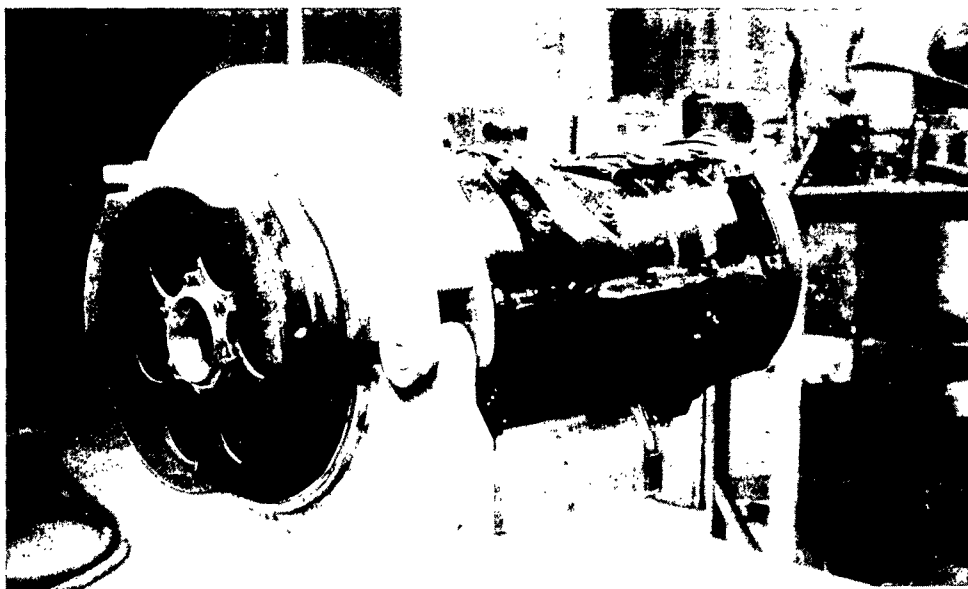
2. Assemble spline shaft to back plate and insert into rotor.

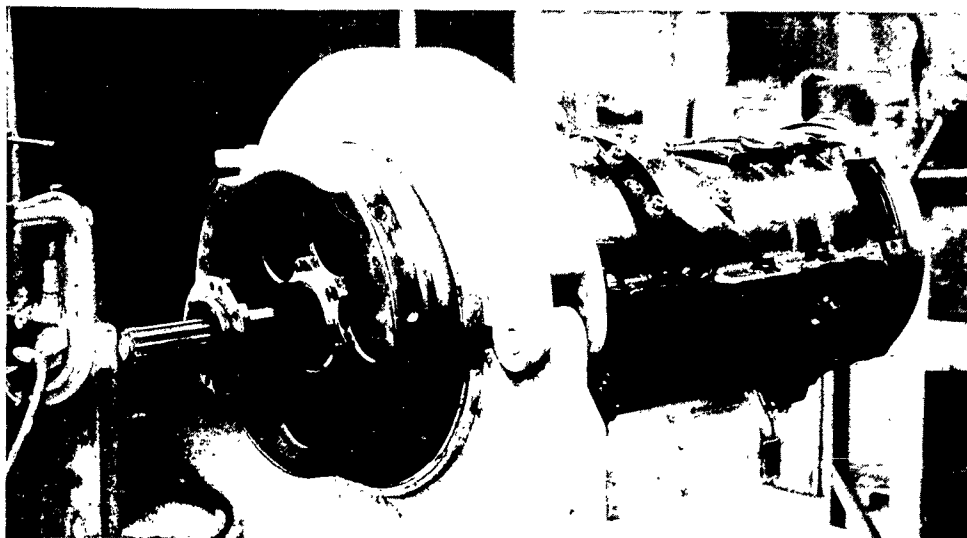
3. Slide ball spline onto spline shaft flange side facing outward.

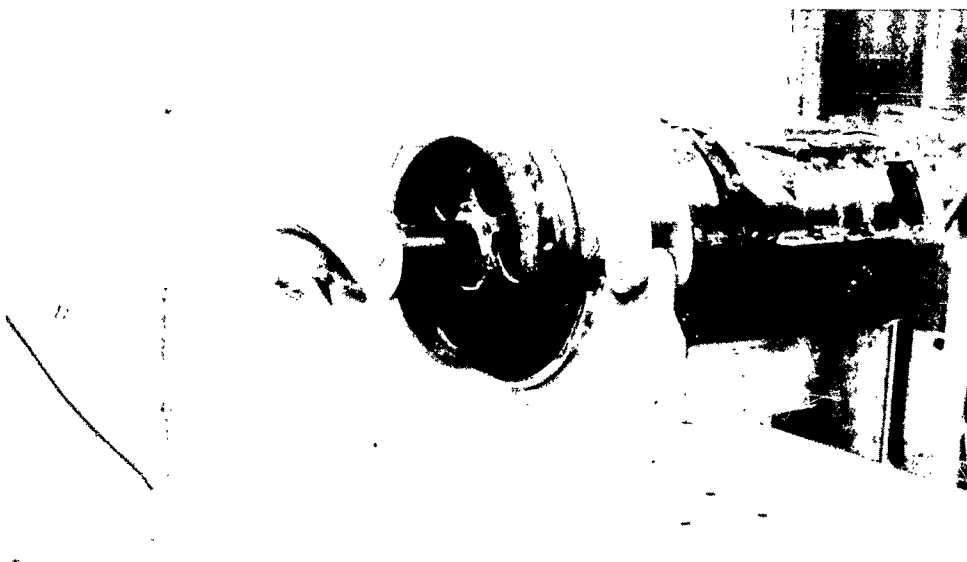
4. Bolt and dowel the cam-piston to the ball spline.

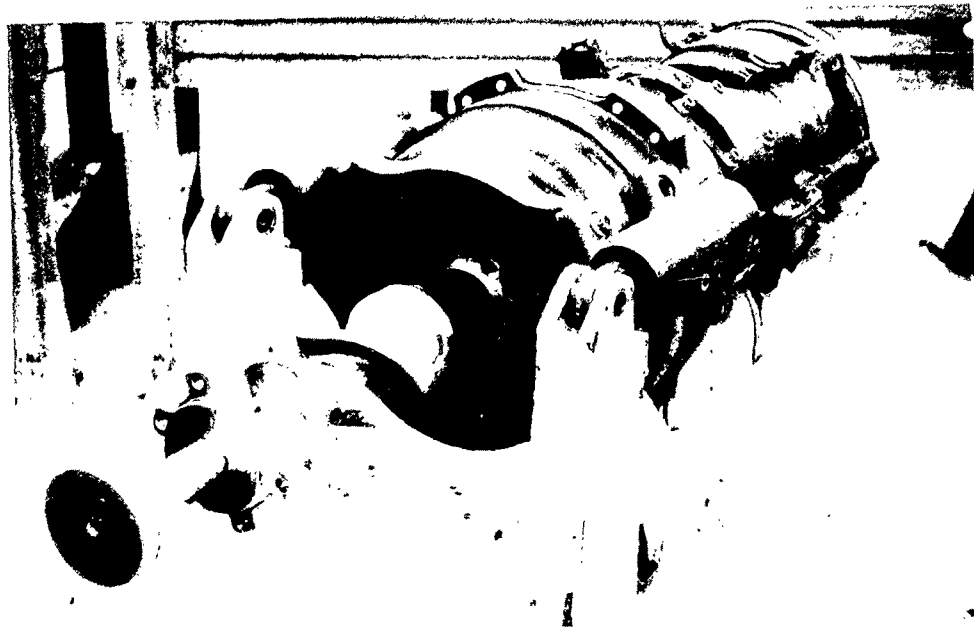
5. Place split end cap onto piston rod.

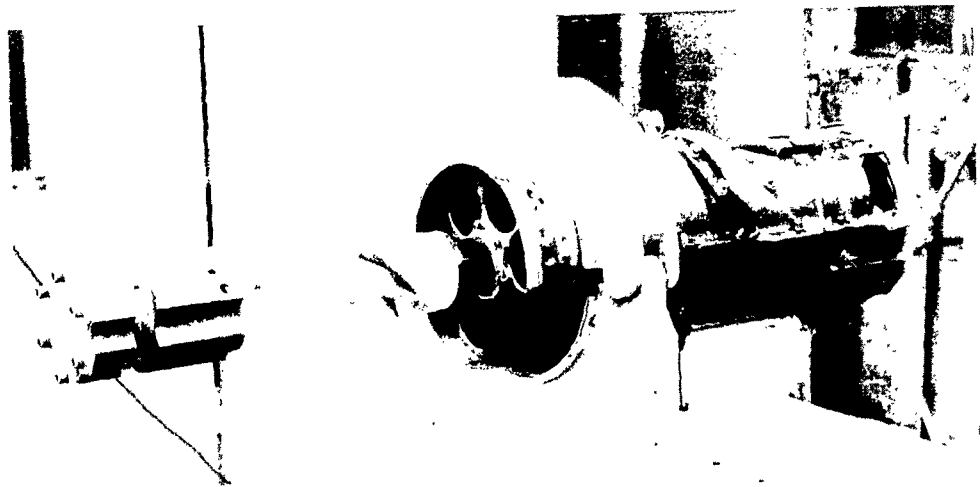
6. Place cylinder onto piston and bolt end cap into place.

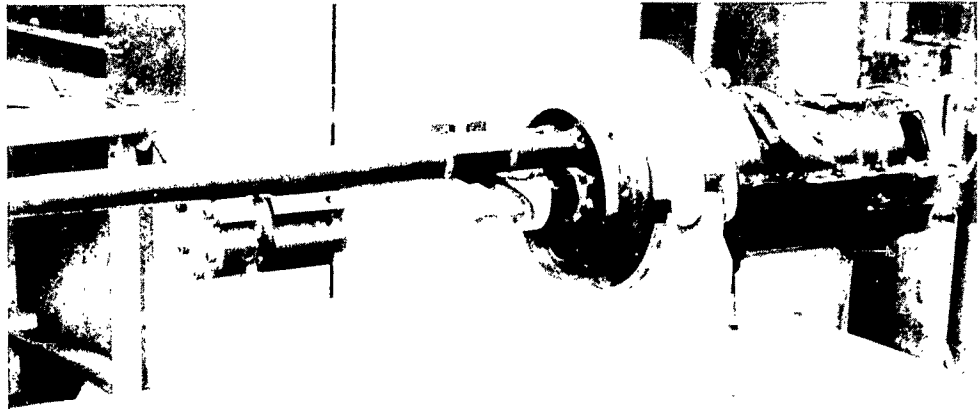
7. Place barrels #1 & #6 onto cylinder and slide into rotor. Push cam against stub rotor, insert inner clamp between barrels. (This is done over a relieved section of the cam for clearance.) Slide cam forward and insert roller into cam path. Assemble outer clamp and roller stud.

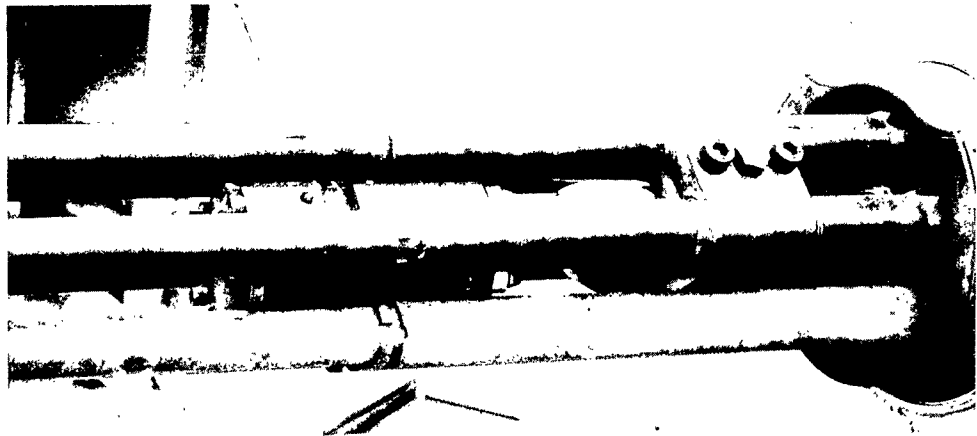
8. Assemble remaining four barrels.

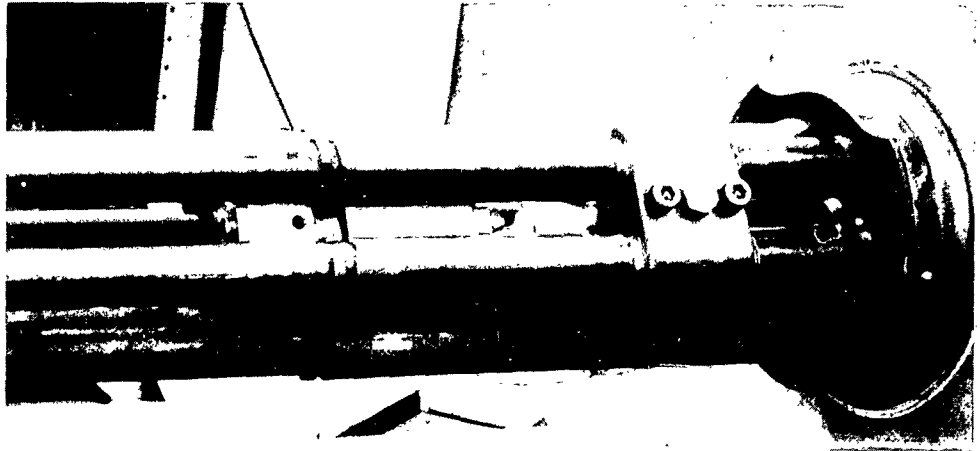
9. Push cylinder rearward until locking tabs on the cylinder are behind the locking rings on the gun barrel.

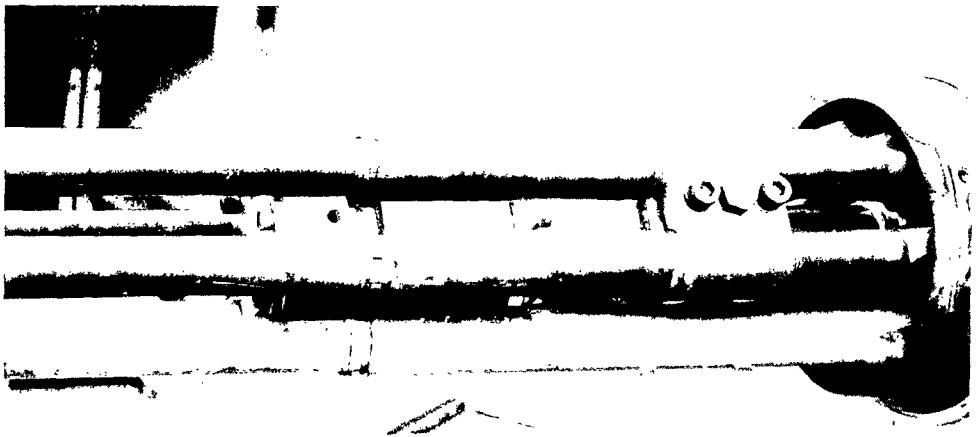
10. Lock barrels in rotor (outer clamp must be loosened to do this).

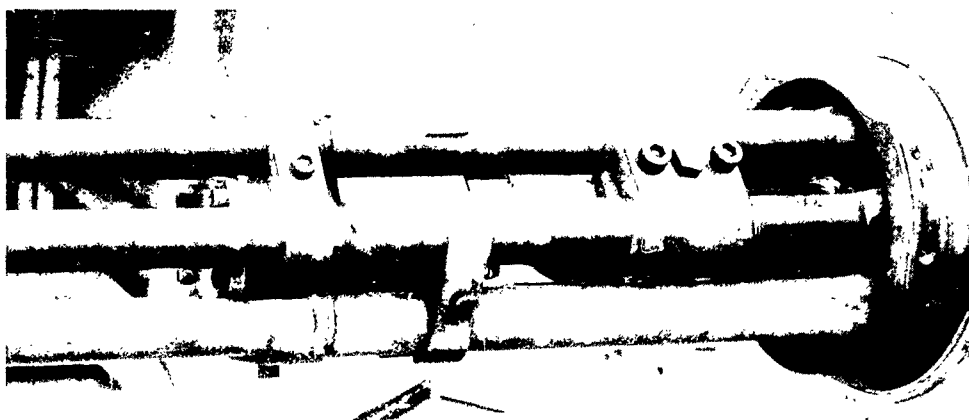
11. Assemble clamps and tighten all bolts. (Photo shows Allen Head cap screws. The proper bolts are external wrenching.)

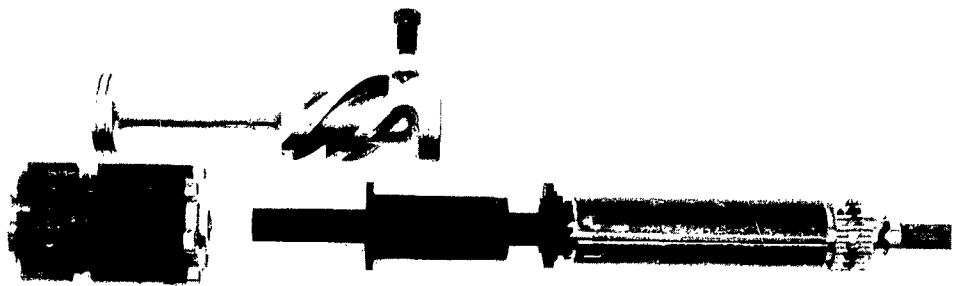
Figure 3-1. Spring Starter System

The spring starter (Figure 3-1) designed for use with the gas drive is a split torque tube type which utilizes the space between the 1.0 inch outer diameter of the gas drive shaft and the 2.25 inch inner diameter of the rotor. The starter system will weigh 12 pounds.

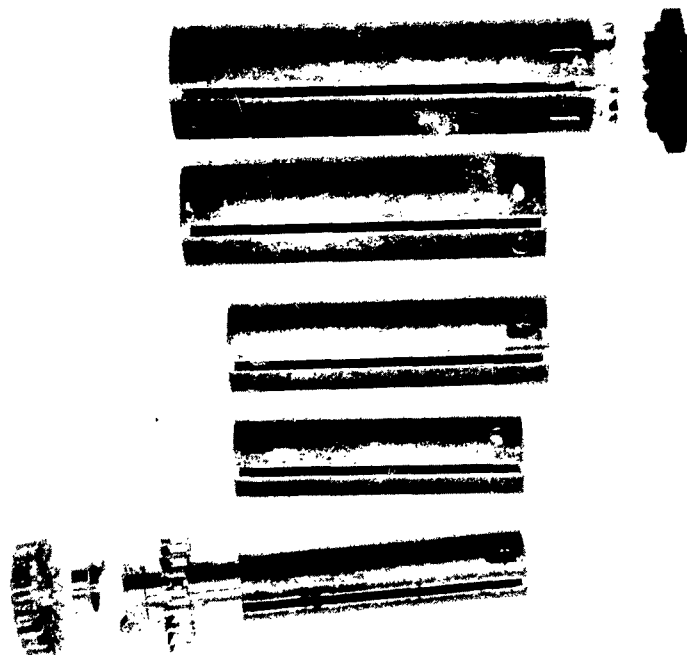
Figure 3-2. Split Tubes

There are five split tubes (Figure 3-2), one inside the other and fastened together at the ends in a series combination to make a 32.35 inch effective spring length. The spring is presently a permanent assembly which can be replaced as a unit. Slots are used in the end connections (Figure 3-3) to allow for the axial movement of the torque tube corners when torque is applied.

Equal spring gradients for the five tubes are maintained by varying their thicknesses from 0.070 inch on the outer tube to 0.080 inch on the inner tube. Total spring weight is 4.14 pounds. A superior spring steel (A1S1 8740) is used for the tubes.

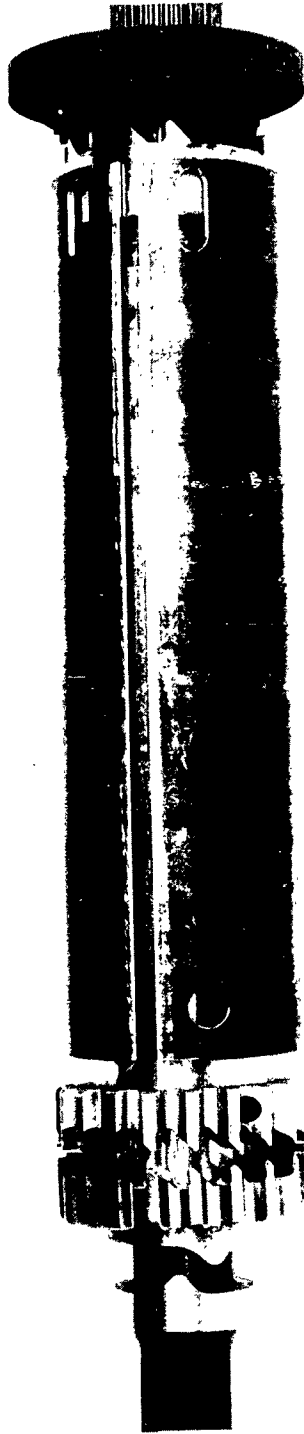
Figure 3-3. Mating of Face Clutch Gears

Face clutch gears which mate with identical gears on the rotor are attached to each end of the spring (Figure 3-3). These gears provide the means of transmitting power from the spring to

the rotor for starting, and from the rotor to the spring for rewind. Helical spines on the inner diameter of each spring gear are the means of grounding the spring to mating splines on the gas drive shaft.

Cams on each end of the shaft are used to initiate de-clutching the spring and rotor gears and engaging the helical splines (Figure 3-3).

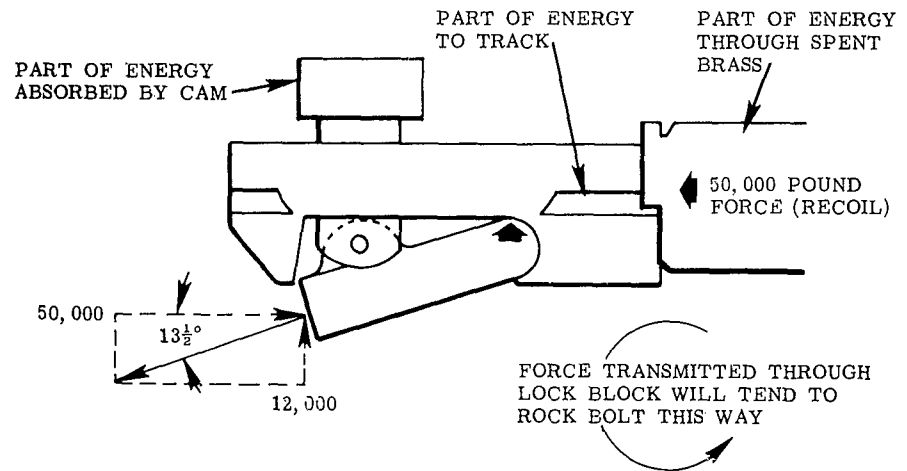
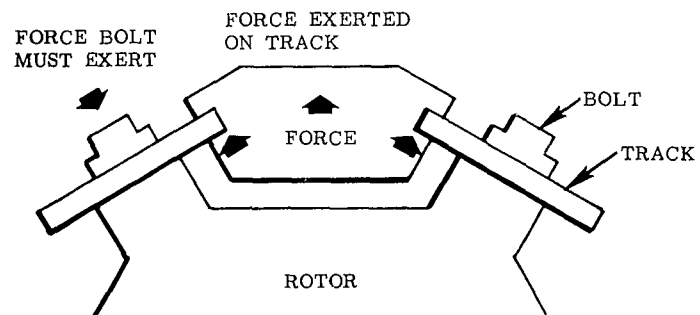
Figure 4-1. Front Track Bolt Forces

Analysis of the forces on the gun bolt during firing show that the track bolt is severely shock loaded in tension with a force of approximately 12,000 pounds (Figure 4-1).

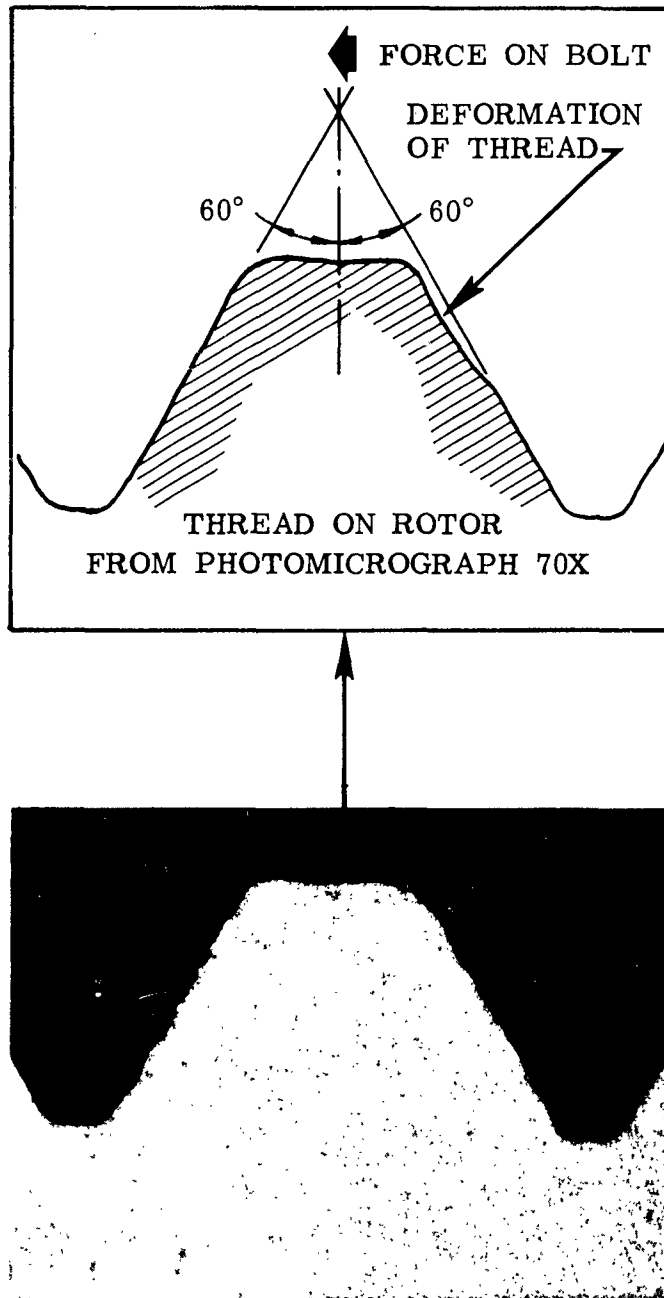
Figure 4-2. Microphotograph of Rotor Threads

The data shows improvement in the loosening effect as the rotor accumulates additional thousands of rounds. This would indicate a possible permanent deformation of metal in some area. Photomicrograph studies of the bolt, rotor and track in the sections in question showed the following effects:

- (1) There was a buildup of silver plate from the track on the edge of the bolt head imprint. This could have occurred at the time the bolts are torqued down but there would have to be a deformation of an order of magnitude greater than there is to account for the amount of torque loss.
- (2) Bolt threads showed strain and evidence of plastic deformation, but this is expected because the threads are rolled onto the bolt shaft after heat treatment. They showed no measurable (at 70 magnification) dimensional deviation, after use, from new threads.

- (3) There was no visible evidence of bolt stretching, although this is a possible but unlikely source of the trouble.
- (4) There was excellent grain structure in the rotor and no evidence of heat treat problems which could contribute to the loss of torque. There was definite measurable distortion at the rotor threads which became more pronounced as the threads get nearer the top (toward the bolt head). Figure 4-2 shows a microphotograph of rotor threads.
- (5) One other point that should be brought out is that there was a substantial difference in the yield strengths of the bolt and of the rotor. The bolt has a yield strength of 180,000/200,000 psi while the rotor has 95,000/110,000 psi. This would indicate that source of the trouble is in the rotor.

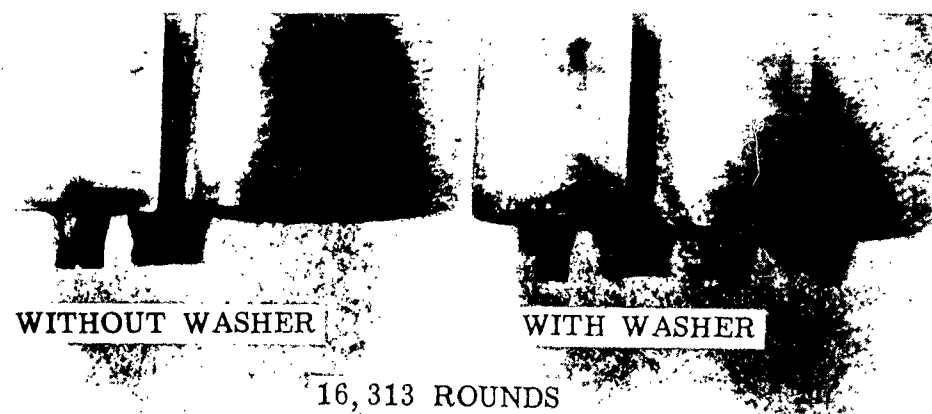
During this reporting period six bolt assemblies with molded in place Kel-F insulation were tested at Aberdeen Proving Grounds. Three of the bolt assemblies had the spring steel washer molded in the Kel-F, three did not. The six sub assemblies were tested for a total of 16,313 rounds (Figure 5-1) at normal temperature and at "D" rate (6,000 spm).

The insulations without the washers cracked in the protrusion area after approximately 8,000 rounds. Misfires occurred at 13,393 rounds and then exceeded one percent during the next 2,920 rounds. At the completion of the test one insulation was completely without the protrusion. There were deep impact marks on the surface of the other two insulations. It is felt that this plastic deformation may have caused some sticking of the firing pin.

The insulations with the spring steel washers showed some severe cracking from the front of the protrusion toward the rear, but there was no indication that these insulations were the cause of misfires.

Figure 5-1. Insulations Fired 16,313 Rounds

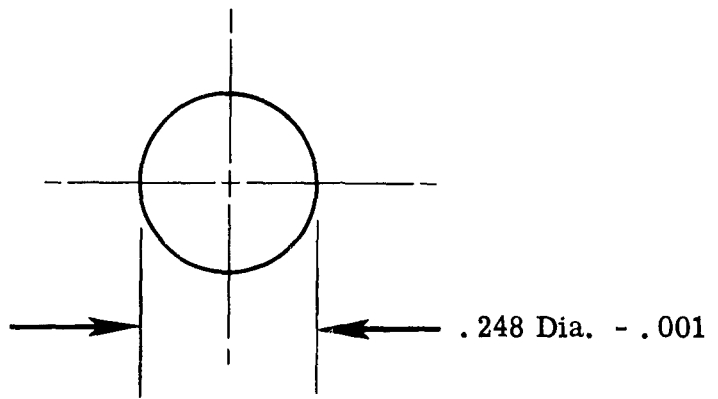
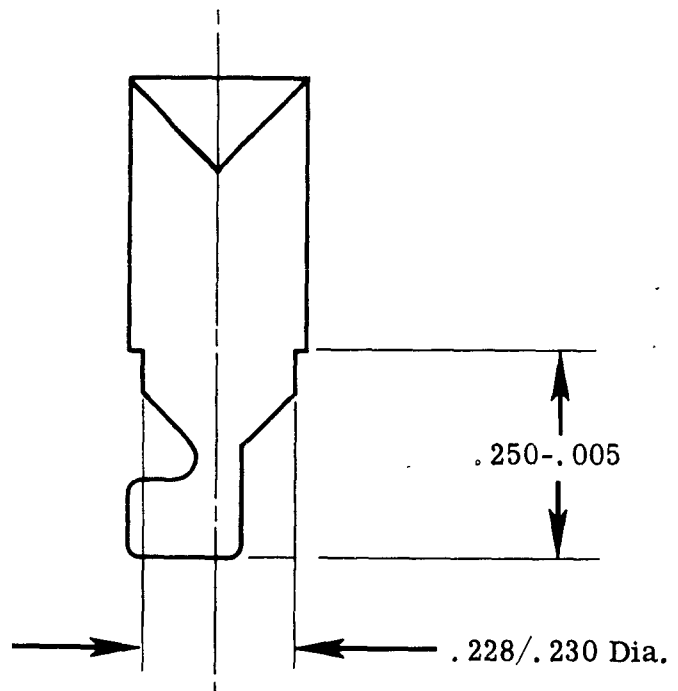
Figure 5-2. Decreased Diameter of Pin, Cam Firing

There was no indication of cracking on the radial-cut rear track lugs or on the roller shafts. At the conclusion of the test, rolls pins on the two that were disassembled showed less than nominal amount of wear. The firing cam pins had free movement.

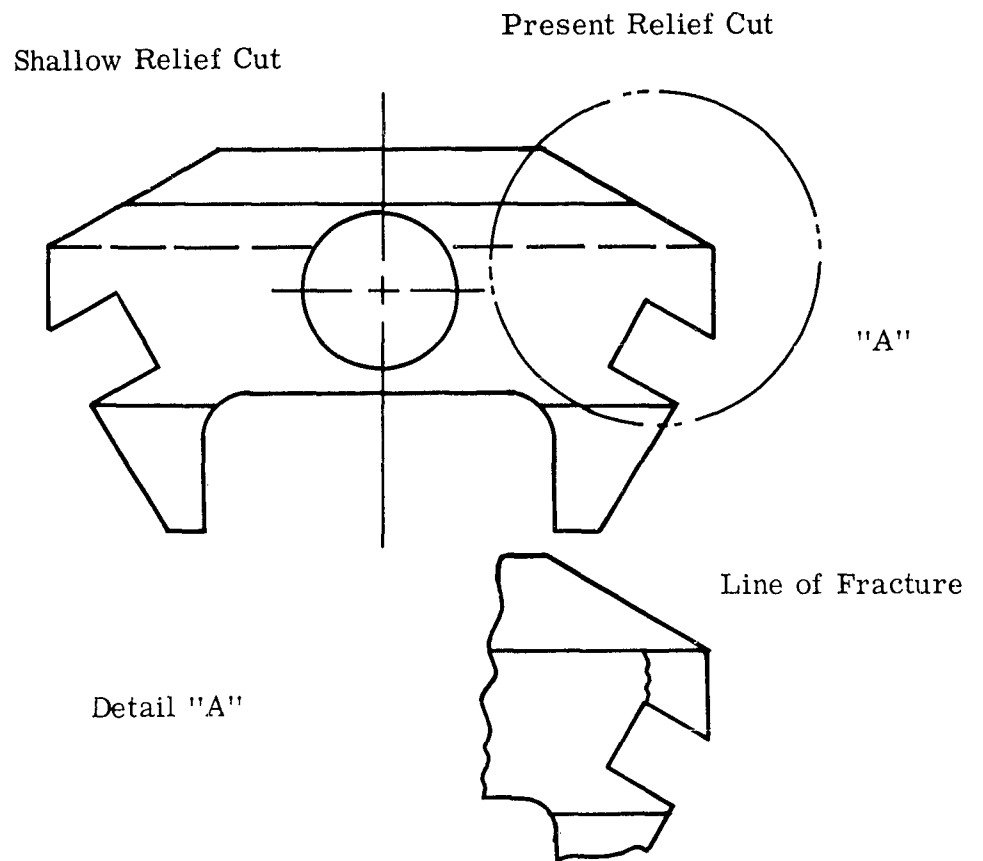
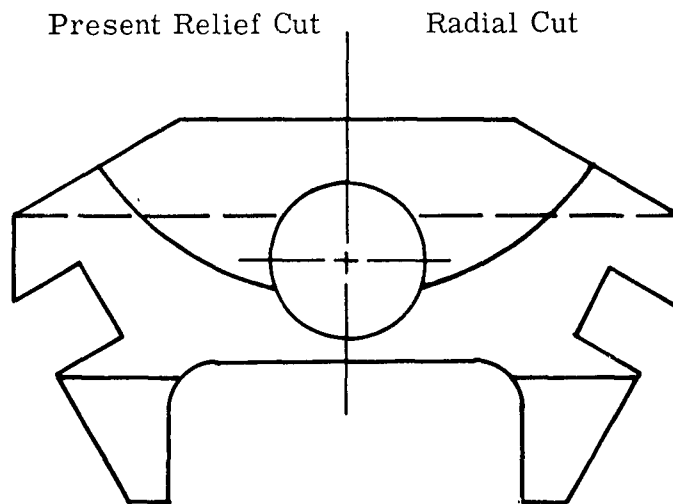
Figure 5-4. Bolt Body Modification

The standard bolt body is subject to failure of the rear lug as its use is extended over the recommended limit. The crack extends across the smallest section (Detail A-Figure 5-4). This cracking occurs much more rapidly when the gun is fired under extreme cold conditions (i. e. , 65° F).

In order to increase the reliability of the bolt as the useful life is increased toward 15,000 rounds, and to increase the parts life in cold conditions, the lightening and clearance cut (Figure 5-4) on the back of the bolt was modified. The weak area is now

strengthened. An additional desirable condition is produced by this radial cut. The weight of the bolt is reduced slightly and this will give a slight decrease of torque in guns using the modified bolt body.
